Nov. 16, 2005

RE: West Side Cameron River Drainages – Cathedral Grove Fish Habitat Assessment.

**Cathedral Grove Fish Habitat -DRC Nov. 2005
Photo Page 1**

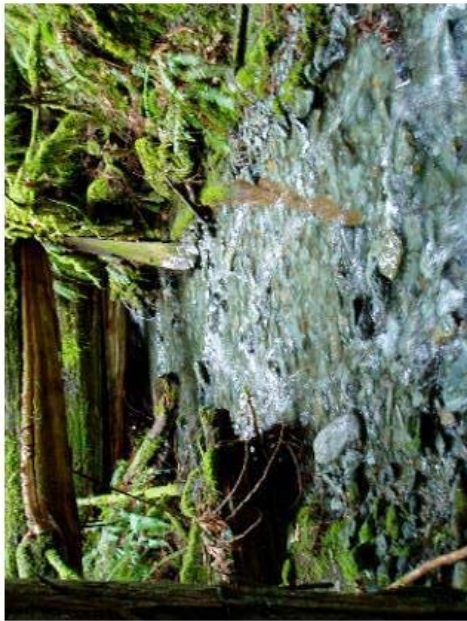
Creek 2: Located at the old south Park Entrance Sign, it has a perennial reach above the highway. This creek offers year round fish habitat for spawning and rearing above the highway. The reach offers approximately 200m of accessible fish habitat as it rises in gradient coming off drainages on the steep east mountain sides. The channel above the highway is a 2.2 m channel with a wetted width in summer of 1.0 m. It has a substrate of 90% gravel and 10 % fines in the riffles. The habitat includes deep scour pools created by LWD. The cool channel offers resident trout year round habitat and migrating fish feeding and/or spawning habitat. The highway culvert is an arch metal pipe that has suitable gradient for fish passage and discharge. It appears that the downstream reach has been disturbed. The channel is braided and loaded with sediment, possibly from Fibre Optic Line Construction. There is also evidence of an old logging road below the highway that may have diverted the creek. The creek skirts a more recent logging block (Lot B) where the remaining logging debris is evident in the channel. This logging debris (Branches and tops was observed throughout the clearing and blocking flow on two other overland channels to the south. This logging debris is creating additional flooding as it impedes drainage through the narrow openings below the Lot B logged area. Creek 2 then enters Floodplain A below the logging area. It falls on a seasonal channel that is low gradient and fish accessible from the Cameron River 1.8 km from the Highway.

1.) Creek 2 above Highway

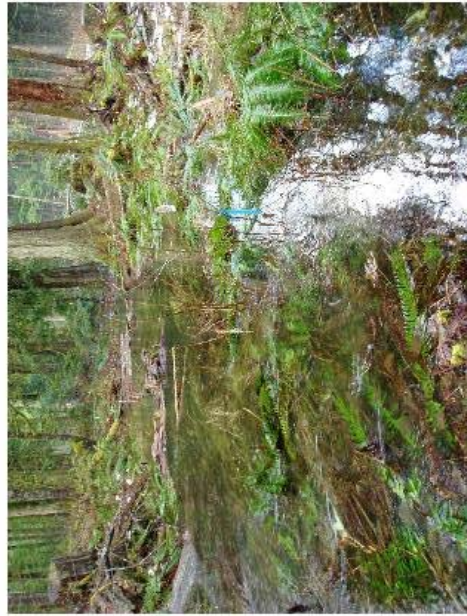
Flood Channel A: The main catchment for all the drainages. It was surveyed March 4 and 10th, 2005. This channel originates above the logging road from groundwater sources. There are several pits from blowdown in the old logging block where at winter flows; the water emerges from the ground. The main channel then crosses the logging road approximately 289 m from the highway in a flowing band over 70m wide and 0.3m deep at flood flows. There is a 800mm metal culvert along the road. It is undersized and poorly located. The road ballast is acting as a barrier to flow to the North.

3.) Floodchannel A just below Logging Rd

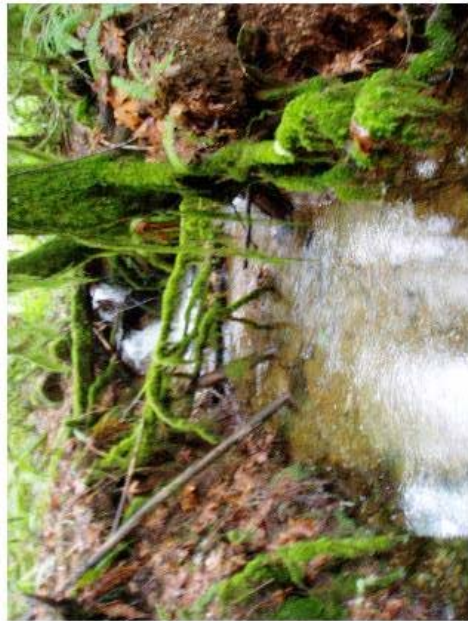
Creek 1: The furthest south drainage we inspected. It comes from the west side mountains and drains across the Fibre Optic Line and Highway at the Logging Truck Sign on the south border of the Park. It has a defined channel above the highway, which is approximately 35m long before it encounters a 1.5 m barrier caused by erosion over a clay seam. Above the barrier the habitat has winter pools but is hummocky and disconnected at normal flow. Water sources are groundwater seepage and surface flow. Above the highway culvert the fish habitat is seasonal with several shallow pools and gravel riffles. The metal culvert is set at 1-2 % gradient and is fish passable. Below the culvert the channel is confined for approximately 30 m and then spreads over the organic forest floor with only swales of needles to determine flow direction. It is dry except for high flows and saturated water tables. The lack of a confined channel below the highway may be due to disturbance of the historic channel or poor location of the culvert. During floods the floodplain of Creek 1 below the highway is a wide band of water that spreads out to several channels. The water heads north to the logging road crossing and enters Floodplain A approximately 200 m downstream.

2.) Creek 1 above Highway

1. There is a perennial reach in Creek 1 above the highway. It is disconnected from lower habitat by braiding and debris jams in the 150 m below the highway and adjacent the old clearcut patch. These areas were damaged by historic logging debris buildup and sediment buildup (Highways grading and possibly fibre optic line construction). The channel would benefit from a stream habitat restoration crew to restructure some of the debris jams to encourage channel confinement and fish access while reducing erosion.
2. The upper reaches of Creek 1 are also braiding due to old growth blowdown. Assessment of restoration action where the channel may blow out and run overland should be done. The

current highway culvert is a continual sediment source from grading and runoff, it needs a more protective apron and sediment traps from ditch lines.

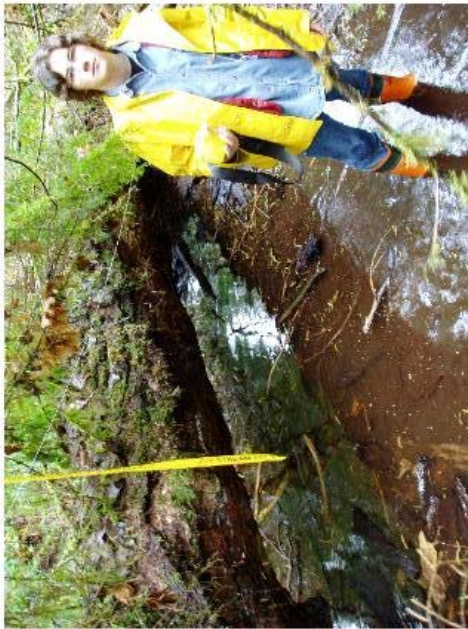
Flood Channel B: This channel is situated in Parking Lot C vicinity. It originates near the North end of Parking Lots A and C. The survey was conducted March 21, 2005. There had been no recent rains and flow was intermittent between some sections. The evidence of higher flow through flood debris and bent over vegetation was evident. The Channel originates from water table seepage from several sources in the second growth forest area. In floods (Jan. 20/05) we found a wetted channel from 1.0 m to 5.0 m wide. There were no fish barriers encountered. As we walked downstream the flood width increased to 8-10 m wide and in some cases it split into two or more channels. It drains north 323m to

4.) Floodchannel B near origin.
